**Third Quarter Vapor Intrusion  
Investigation Report  
North Bronson Industrial Area  
Operable Unit 1  
Bronson, Michigan**

**NBIA OUI PRP Group**

**December 2008**

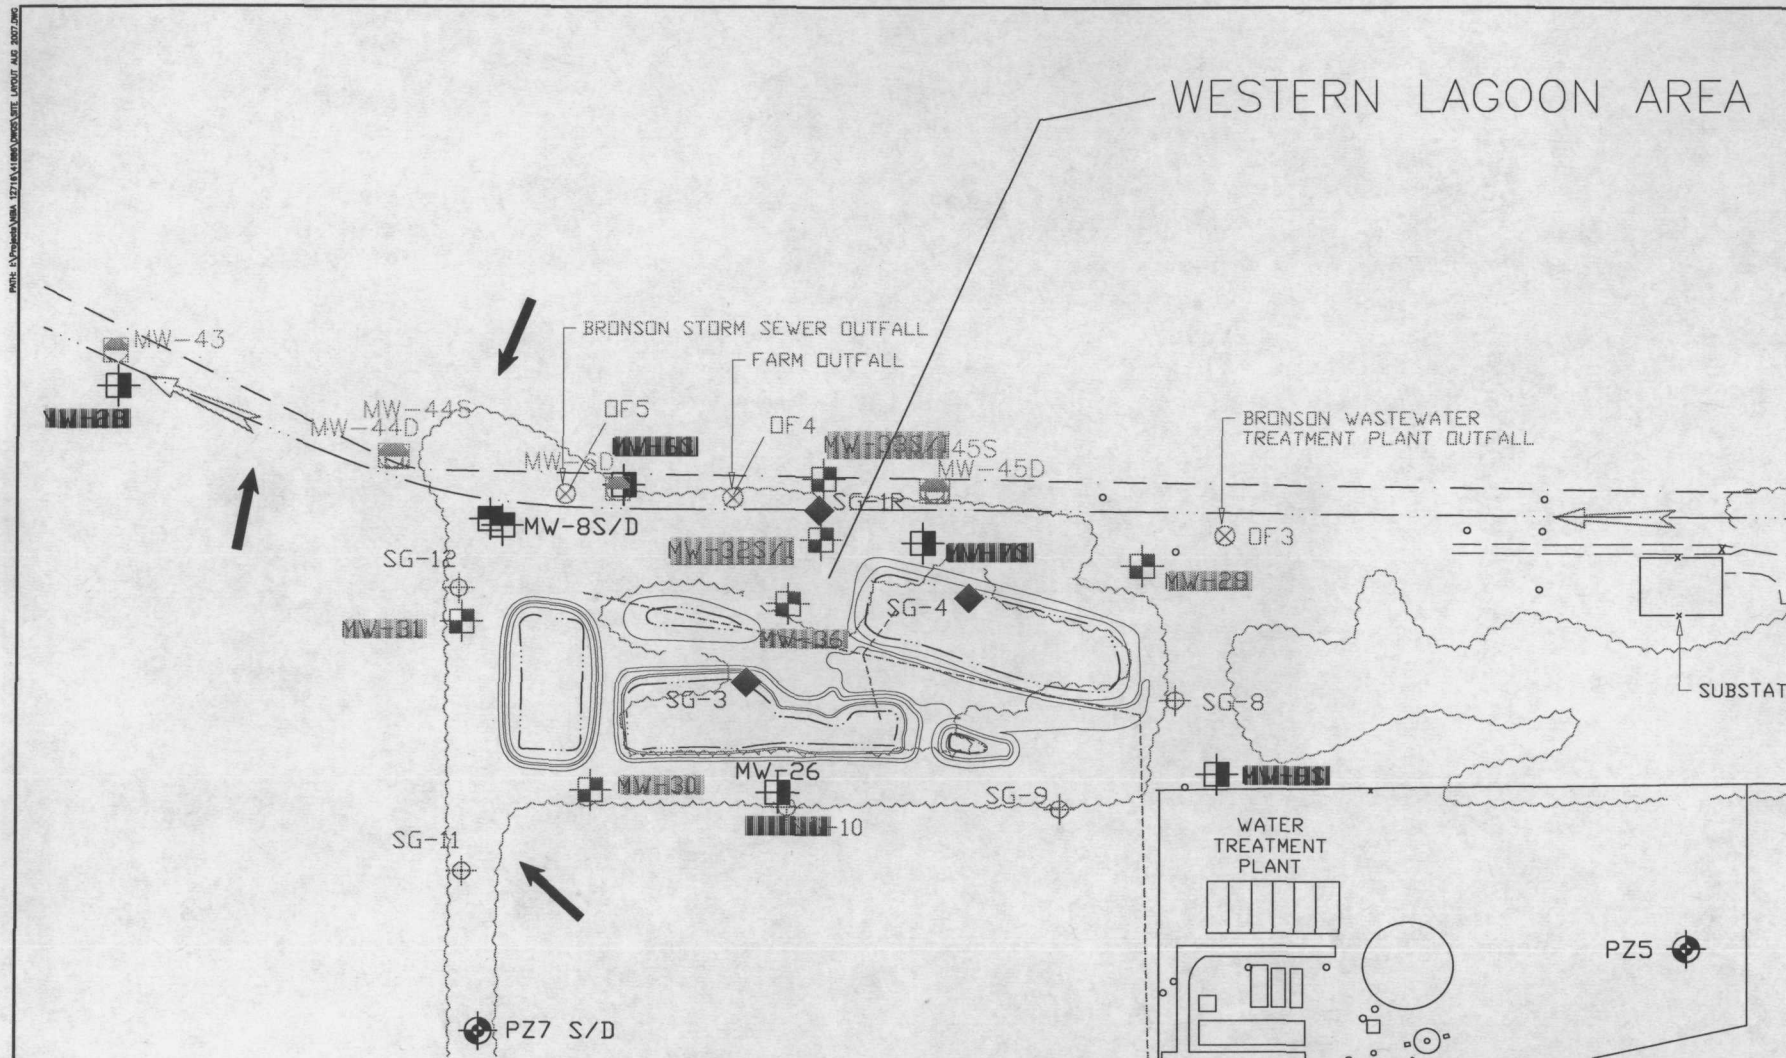
FIGURE 2

Soil vapor sampling locations SG-8 and SG-9 (Figure 2) were strategically located between the WLA and the City of Bronson Wastewater Treatment Plant (WWTP) near the alignment of the city storm sewer that could potentially act as a preferential pathway for soil vapor migration. Compared to sampling adjacent to the WWTP, the selected locations of SG-8 and SG-9 were intended to provide more definitive information regarding the potential for soil vapors originating at the WLA to impact the main building of the WWTP. The WWTP is generally upgradient of the WLA and at a distance of at least 300 feet (Figure 2).

SOIL GAS (VAPOR) SAMPLING LOCATIONS

The vapor probe locations provide information regarding the potential presence of soil vapor migration in the vicinity of the WLA to the east, south, and west and are designed to identify the potential for soil vapor intrusion in the event that structures would be built near the lagoon area. County Drain #30 forms the northern perimeter of the WLA, and this incised drainageway significantly reduces the potential vapor intrusion concerns to the north by truncating the vadose zone in this area.

The location and surface elevation of the soil vapor probes were surveyed using a survey-grade global positioning system (GPS) by a licensed surveyor in October 2008, while the surveyor was conducting other surveying activities at the site. The locations and elevations of the soil vapor probes were surveyed using the same coordinate system used for other surveys within the NBIA Site and were incorporated into the existing Site base map (Figure 2).
